Manhole Inspection Summary

Manhole # S51A__034MH

Insp Date: **10/1/08 9:59 AM**

Location Address: **2814 pulaski hw**

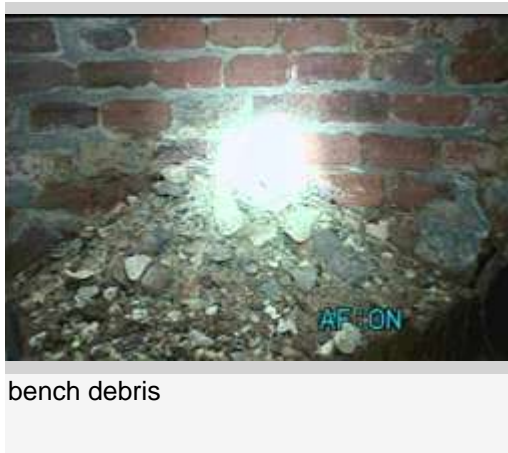
Defect 4

Condition: ☐ Sound ☐ Cracked ☐ Root Intrusion ☐ Deteriorated ☐ Leaks ☒ **Debris**

bench debris

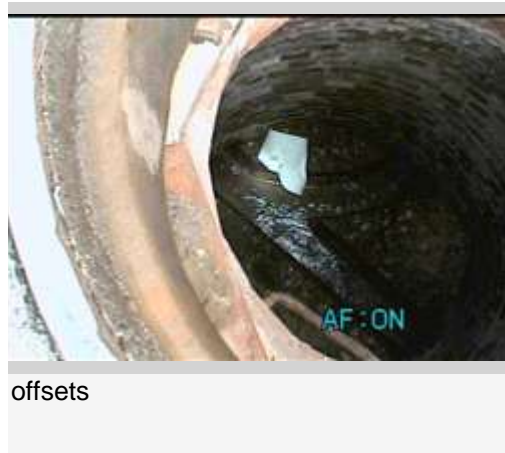
Defect 3

Offset: **2** (in.)

offsets

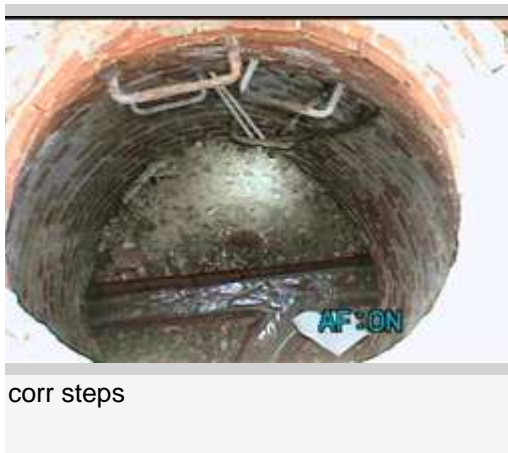
Defect 2

Count: **4** Missing: **0** ☒ **Corroded**

corr steps

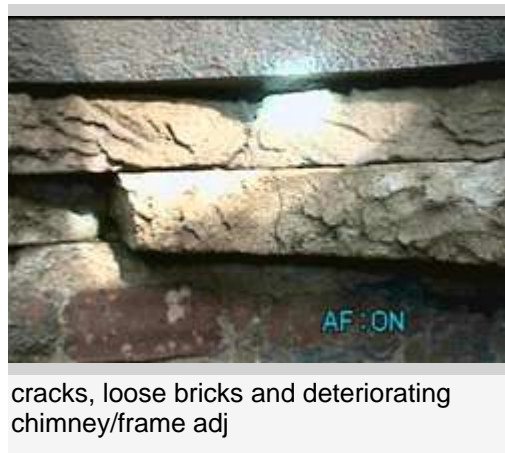
Defect 1

Condition: ☐ Sound ☒ **Cracked** ☐ Root Intrusion ☒ **Loose Brick** ☒ **Deteriorated**

cracks, loose bricks and deteriorating chimney/frame adj

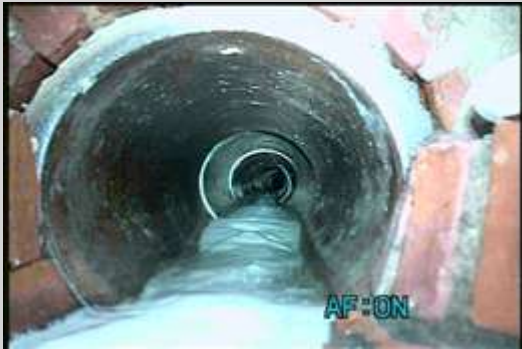
12 O'Clock Outflow

10 in. Circular Gravity Sewer
Pipe Out @ 12 O'Clock

Invert Depth: **8.50** (ft.) Flow Characteristics: **Fast**

Deposits: ☒ None ☐ Mud ☐ Sludge ☐ Debris ☐ Grease

Infiltration: **None** Pipe Seal Cond: **Unknown**

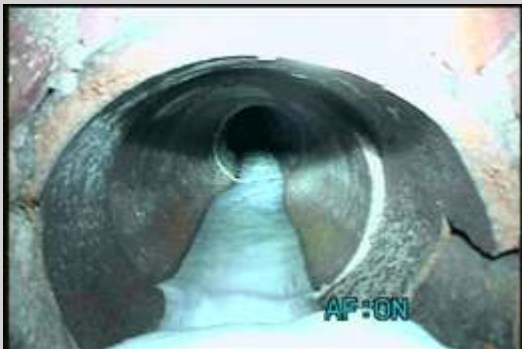
3 O'Clock Inflow

8 in. Circular Gravity Sewer
Pipe In @ 3 O'Clock

Invert Depth: **8.30** (ft.) Flow Characteristics: **Slow**

Deposits: ☒ None ☐ Mud ☐ Sludge ☐ Debris ☐ Grease

Infiltration: **None** Pipe Seal Cond: **Unknown**

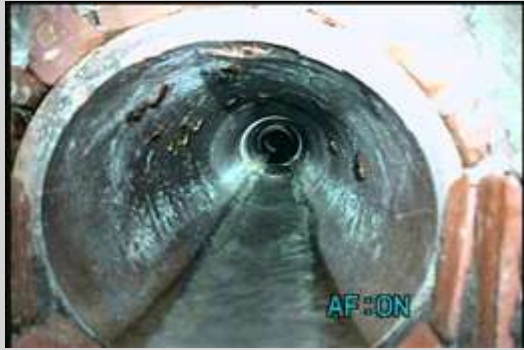
6 O'Clock Inflow

10 in. Circular Gravity Sewer
Pipe In @ 6 O'Clock

Invert Depth: **8.20** (ft.) Flow Characteristics: **Fast**

Deposits: ☒ None ☐ Mud ☐ Sludge ☐ Debris ☐ Grease

Infiltration: **None** Pipe Seal Cond: **Unknown**
